AFLOAT REPAIRS

Innovative 3D Liner Scan Inspection without Immobilisation

VESSEL: Oil Tanker

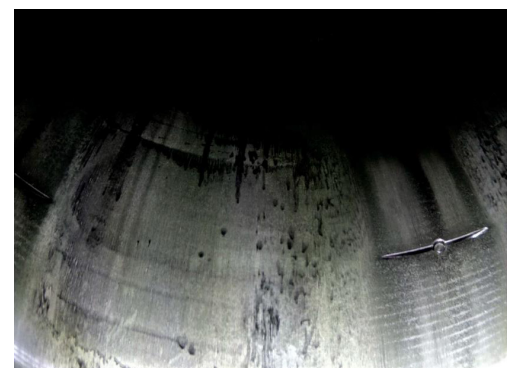
Liner and Cyl Cover

Faulty Liner Intellegently Inspected In-Situ

In this case, the liner of one of the 6 units was completely scuffed though the other 5 liners were in good condition.

The data and photos proved that the liner in its entirety was scuffed. Possible causes are the failure of the alpha lubricator for that unit.

The results of the inspection and analysis were thorough and successfully evidenced so that the advice we offered to the Client, was well founded and quantifiable. We advised the Client to renew the liner at the earliest opportunity to prevent failure of rings.
