AFLOAT REPAIRS

Innovative 3D Liner Scan Inspection without Immobilisation

VESSEL: Oil Tanker

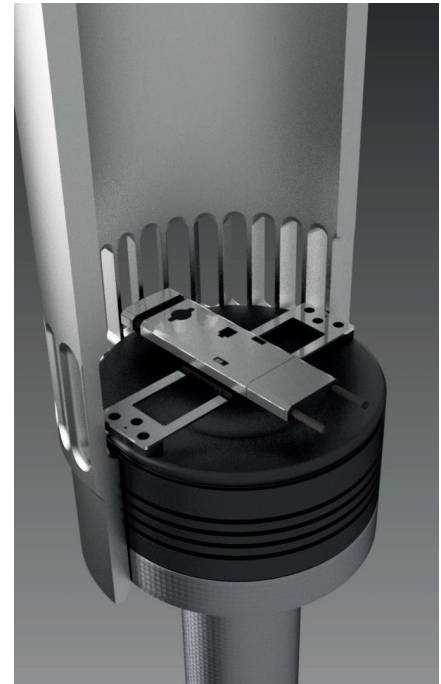
In this case, the liner of one of the 6 units was completely scuffed though the other 5 liners were in good condition.

The data and photos proved that the liner in its entirety was scuffed. Possible causes are the failure of the alpha lubricator for that unit.

The results of the inspection and analysis were thorough and successfully evidenced so that the advice we offered to the Client, was well founded and quantifiable. We advised the Client to renew the liner at the earliest opportunity to prevent failure of rings.
